# 930,599 Mile Engine 1 Million Mile Van

# Delivery Driver Tests AMSOIL

# CHRONOLOGY OF ANALYSIS

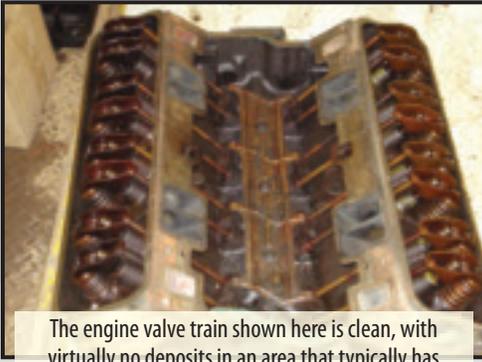
The engine valve train shown here is clean, with virtually no deposits in an area that typically has sludge and heavy carbon buildup with conventional motor oil.

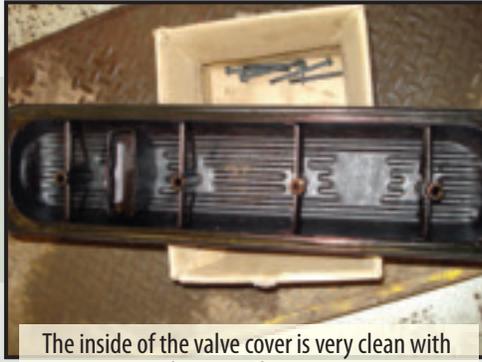
The inside of the valve cover is very clean with almost no deposits.

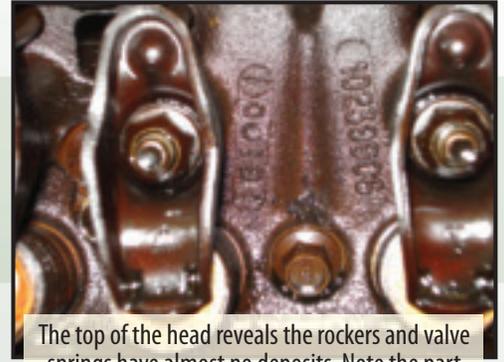
The top of the head reveals the rockers and valve springs have almost no deposits. Note the part numbers still are visible.

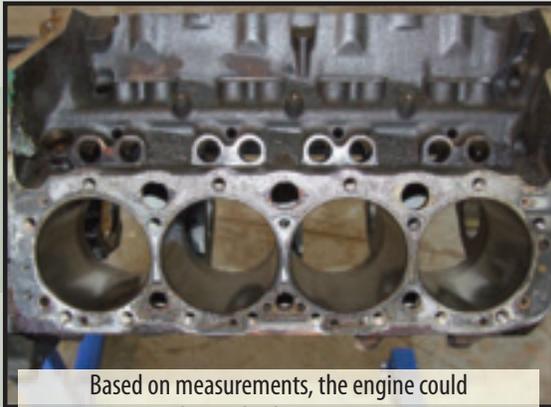
Based on measurements, the engine could be put back in service.

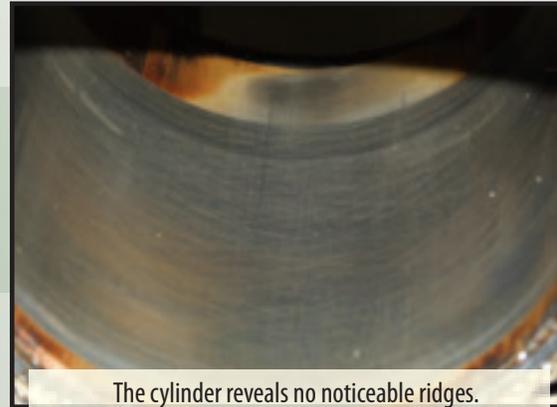
The cylinder reveals no noticeable ridges. Note crosshatch marks still are present.

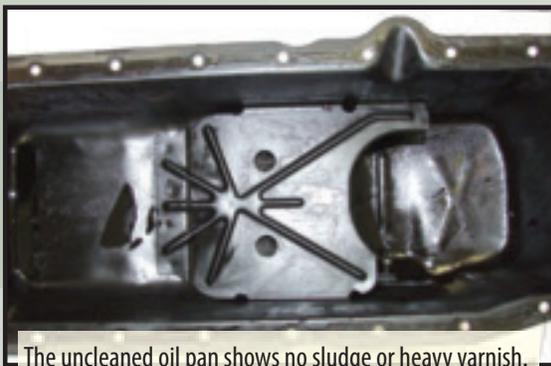
The uncleaned oil pan shows no sludge or heavy varnish.

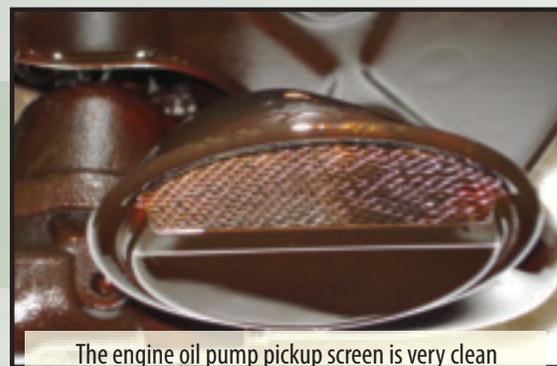
The engine oil pump pickup screen is very clean and has no deposits.

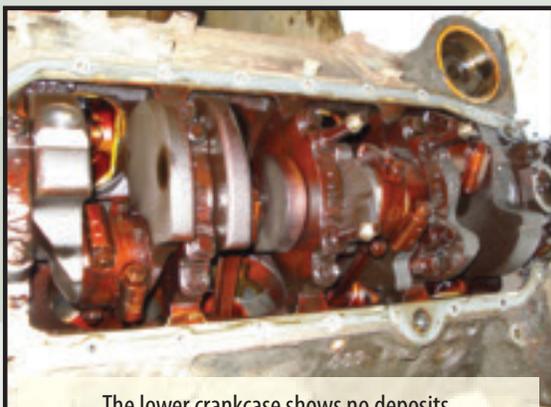
The lower crankcase shows no deposits.

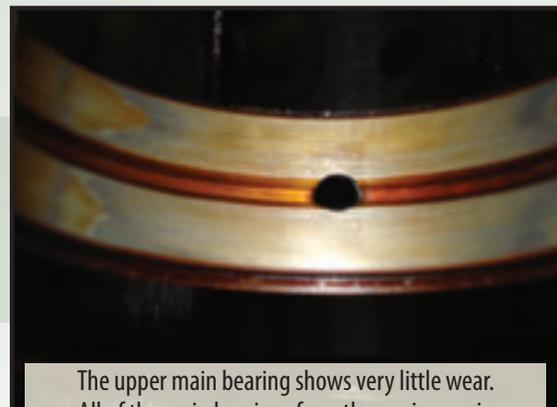
The upper main bearing shows very little wear. All of the main bearings from the engine are in useable condition, according to the analysis.
